Evaluating the effects of wrinkle bends

Study examines the impact of wrinkle bends on pipeline integrity and assesses the use of composite materials for life extension.

Dr. Chris Alexander, *Stress Engineering Services, Inc., Houston, Texas*

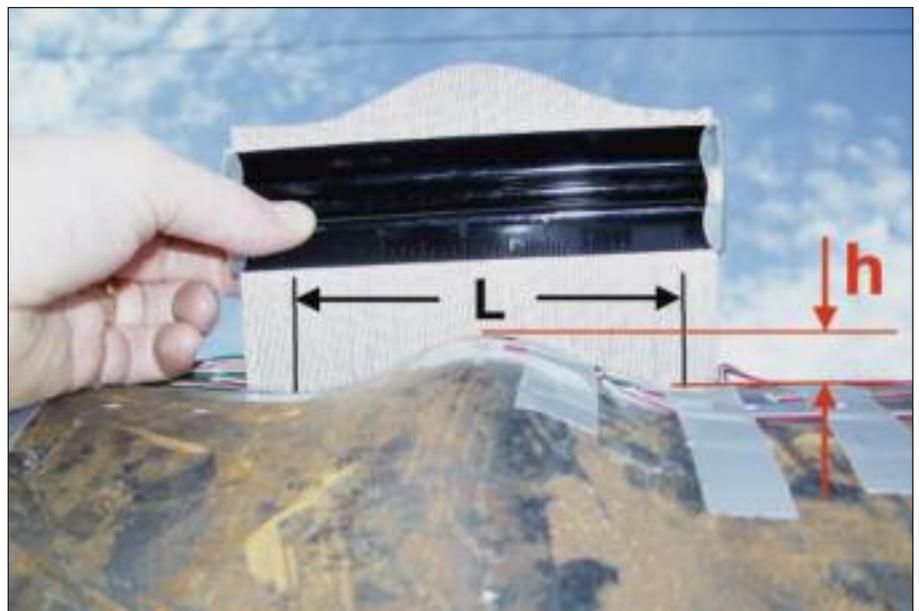
Figure 1. Measurement made using steel profile comb with "h" and "L" values.

A useful tool for measuring the wrinkle profiles is the steel profile comb. A photograph showing the use of this comb on Sample EP22-1B is shown in Figure 1. Using this tool provides a quick check on the h/L ratio as the profile can be traced onto a sheet of paper, thus permitting h and L to be measured. Also shown in this figure are the geometric wrinkle bend variables associated with the length, L , and height, h , values. The length, L , is represented as the distance over which the curvature of the wrinkle decays back to the original profile of the pipe. For the pipes used in this study, the length was relatively well defined as the pipe was generally straight outside of the wrinkle. This might not be possible for all wrinkle profiles.

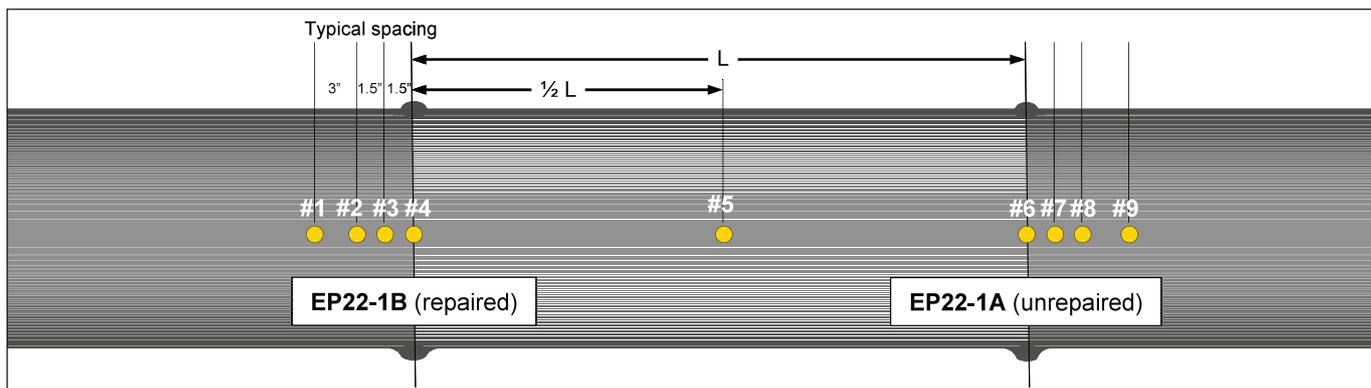
Figure 2. Schematic showing strain gage locations (markings specifically for the gage configuration on Sample EP22-1).

Figure 2 is a schematic diagram showing where strain gages were installed on each wrinkle. As noted, there are two wrinkles on each test sample and a middle gage at location #5 was installed on the bare pipe between the wrinkles to capture nominal hoop and axial strain values. As noted in this figure, a total of nine strain gages were installed on each test sample. For the pressure cycle testing, data were recorded at 1 scan per second. After testing, the results were post-processed.

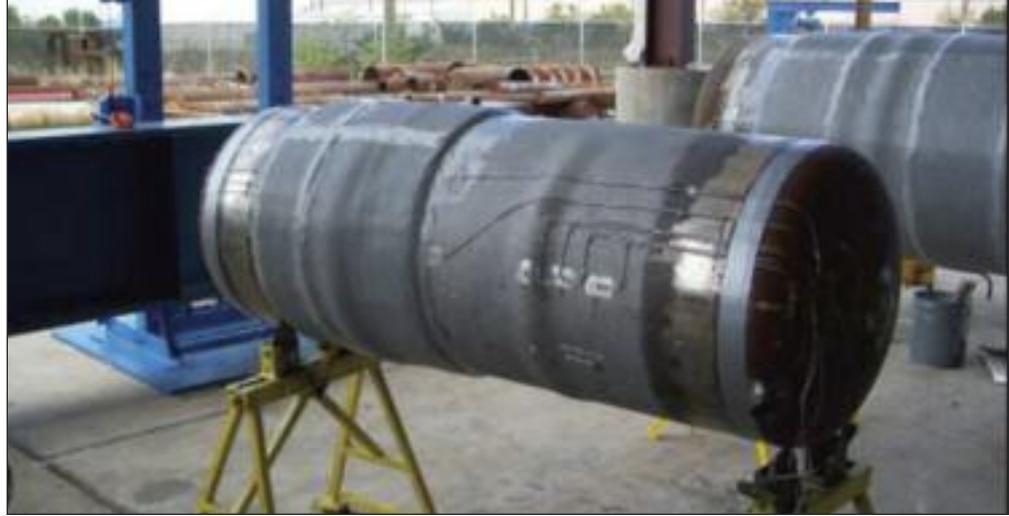
Figure 3. Photo showing completed installation of composite material.

Strain gages were installed prior to installation of the composite material. Epoxy putty was used to create a smooth profile around the strain gage lead wires. Additionally, a layer of epoxy was painted to seal the exposed pipe prior to installation of the reinforcing material. Figure 3 shows a completed repair on the pipe sample using the composite reinforcement.

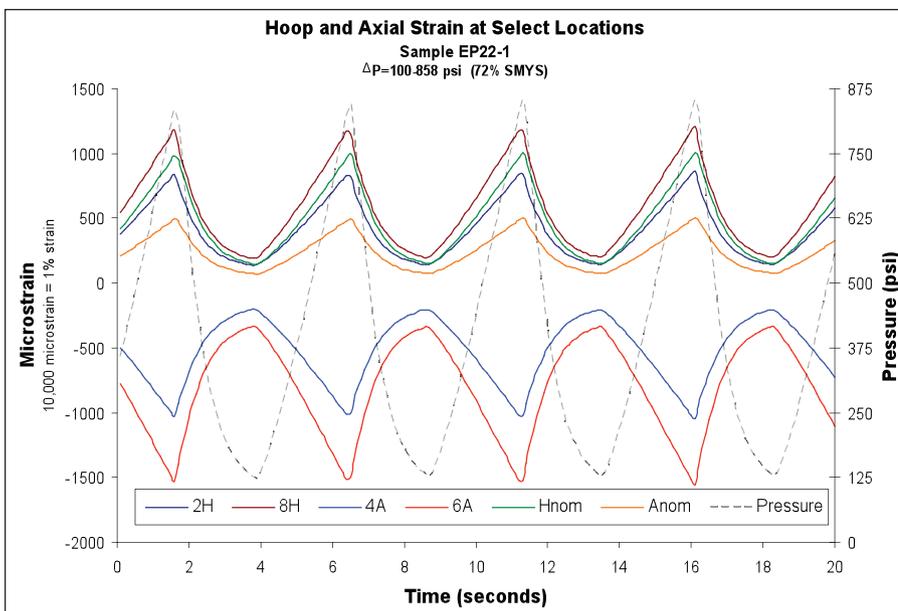
- As expected, the maximum strains are measured in Sample EP30-1 where 40 percent of the wall thickness was removed to simulate corrosion. This increased strain results in fatigue life reduction.
- The contribution of the composite materials reduces strain in the reinforced wrinkles. On average, the strain reduction is 42%. Considering a fourth order relationship between cycle life and strain range, a 30% reduction in stress effectively increases fatigue life by a factor of approximately 4.
- Elastic stresses are computed by multiplying the measured strain ranges by 30.

Figure 4. Alternating hoop and axial strain gage results for Sample EP22-1.
