## EVALUATING THE USE OF COMPOSITE MATERIALS IN REINFORCING OFFSHORE RISERS USING FULL-SCALE TESTING METHODS

**Chris Alexander**  
Stress Engineering Services, Inc.  
Houston, Texas  
[chris.alexander@stress.com](mailto:chris.alexander@stress.com)

### ABSTRACT

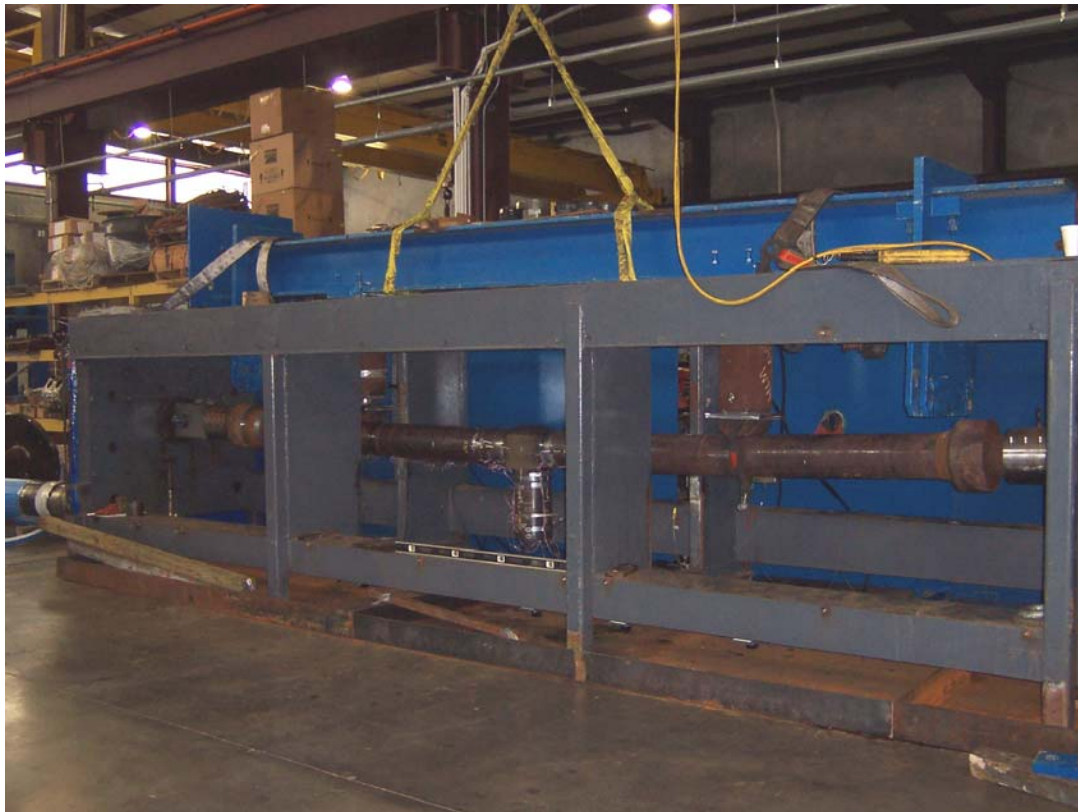
**Figure 6 – Load frame used for pressure-tension-bend testing**

Figure 5 shows the location of the strain gages placed on the pressure-tension-bend samples. As with the other two tests, nine strain gages were installed on the pipe and three were installed on the outside surface of the composite repair after curing had taken place. Figure 6 shows the load frame used for the bend tests. This load frame has an axial tension capacity of 1 million lbs and can apply bending loads up to 750 kip-feet.

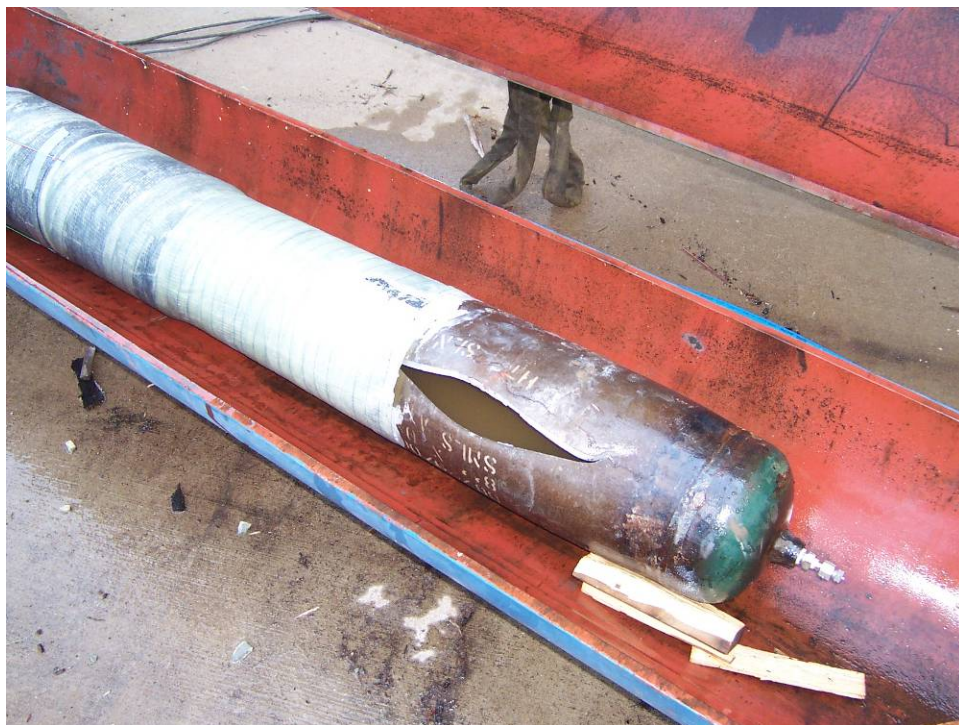
**Figure 8 – Failure in burst sample using Product C**

- The unrepaired sample failed at a pressure of 3,694 psi. Failures in the test samples prepared using Products A, C, and D occurred in the steel away from the repaired region. Figure 8 shows the failure in the Product C repaired sample outside of the repaired region in the base pipe. This failure was typical for the repaired samples.

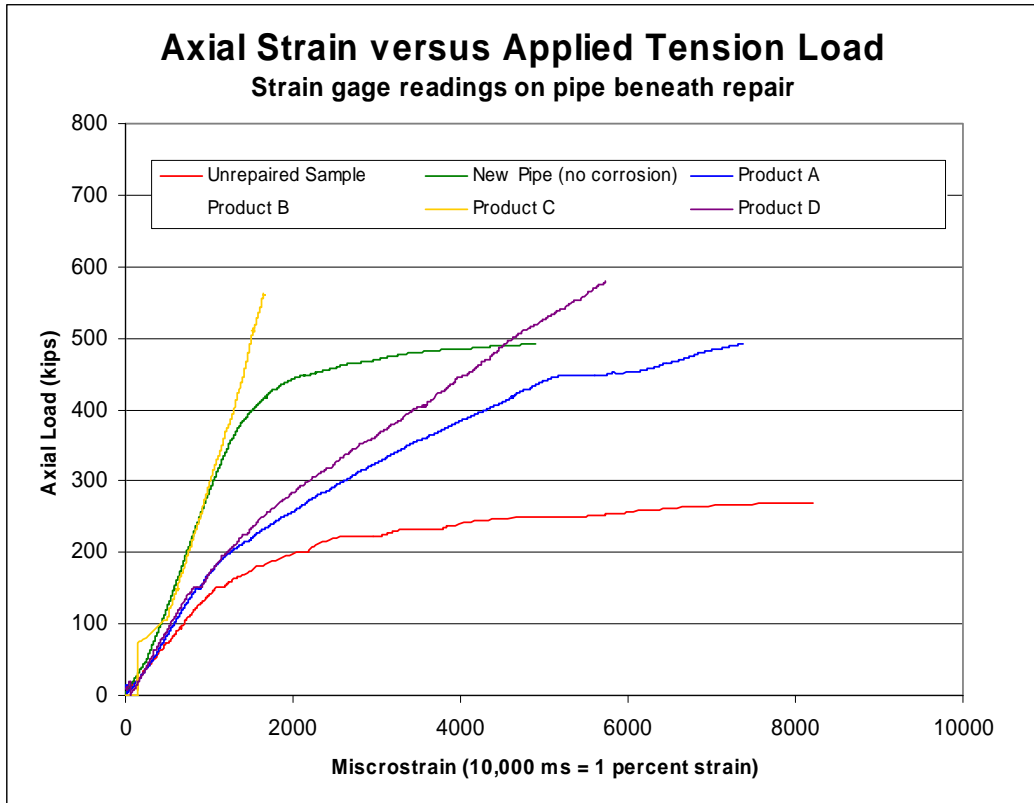
Figure 9 – Test results from pressure-tension testing

Results for the pressure-tension test are provided in Figure 9. This phase of testing primarily assessed the lap shear strength of the adhesive that bonded the composite reinforcement to the steel pipe. This failure condition was anticipated prior to testing and was the basis for the minimum repair length of 60 inches. Several noteworthy observations are made in reviewing the test data presented in Figure 9.

- Product C shows the greatest axial rigidity of all the repair systems. The basis for this observation is that Product C was fabricated using carbon fibers, with a large percentage of fibers being oriented axially. Products A and D show similar levels of reinforcement up to 200 kips, while after this point Product D shows greater reinforcement.
- The following tension failure data were recorded.
  - Unrepaired sample – 317 kips
  - Product A – 492 kips
  - Product B – data not reported
  - Product C – 562 kips
  - Product D – 579 kips

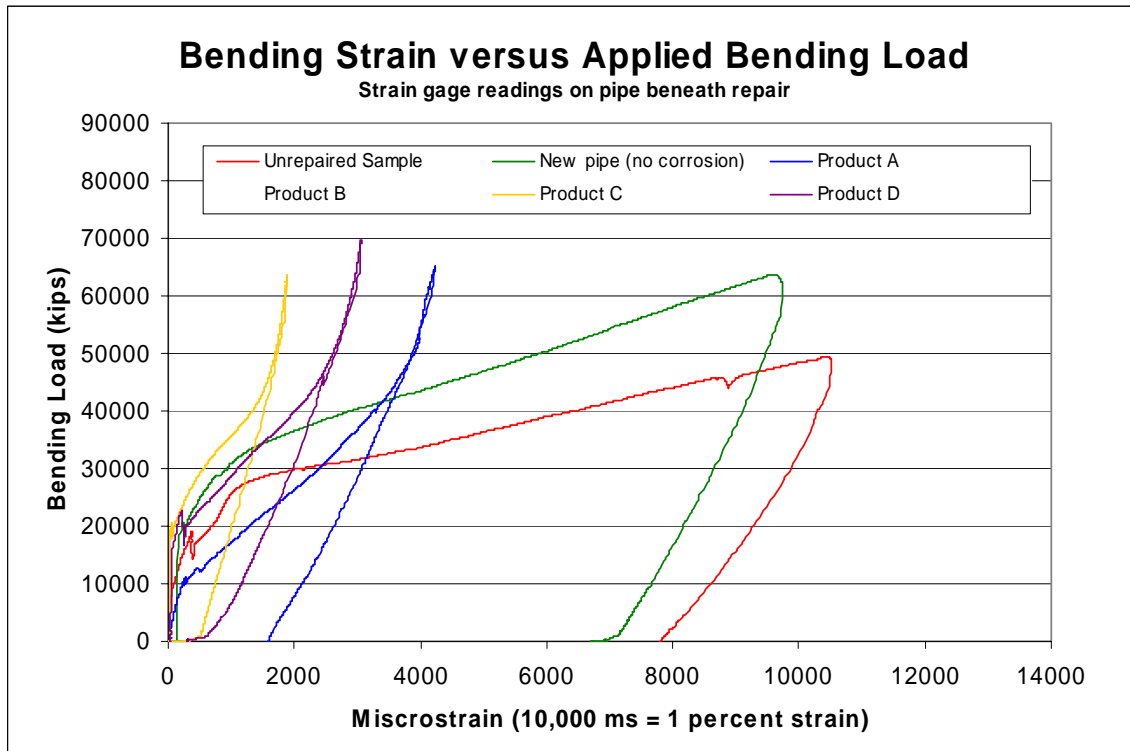
Figure 11 – Test results from pressure-tension-bending testing

Results for the pressure-tension-bending test are provided in Figure 11. There are several noteworthy observations in reviewing the plotted data.

- Unlike the other tests, there is a unique pattern observed for the level of reinforcement provided by each of the respective repair systems. As expected, the carbon in Product C provides the greatest level of reinforcement because for any given bending load it had the lowest measured strain. For comparison purposes, consider the strain in the steel at a bending load of 40 kips (bending moment of 116.7 ft-lbs) for each of the repair systems:

- Product A – 4,130 microstrain
  - Product B – data not reported
  - Product C – 2,150 microstrain
  - Product D – 3,022 microstrain
- In assessing the relative performance of the composite systems, the objective of the repair is to reduce the strain in the corroded steel during bend testing, as well as provided reinforcement in the circumferential and axial directions due to internal pressure and axial tension loads, respectively. As noted in Figure 11, at some point the strain gage results appear to stop changing with increasing load (plotted lines trend vertical). It is at this point that gross plastic deformation, as recorded by the strain gages, occurs outside of the reinforced region and that deflection is occurring primarily in areas outside the composite reinforcement. The sooner this transformation takes place, the more effective the repair is in reinforcing the corroded region.

- Another option for assessing the relative performance of the composite repair systems is to determine the applied bending moment at a specified strain value. If the strain limit is 0.20 percent, the following bending forces and moments are extracted. This method is a better assessment of the relative performance of the repair systems. It should be noted that the unreinforced sample did not include internal pressure during bend testing as failure would have occurred at a lower bending load.

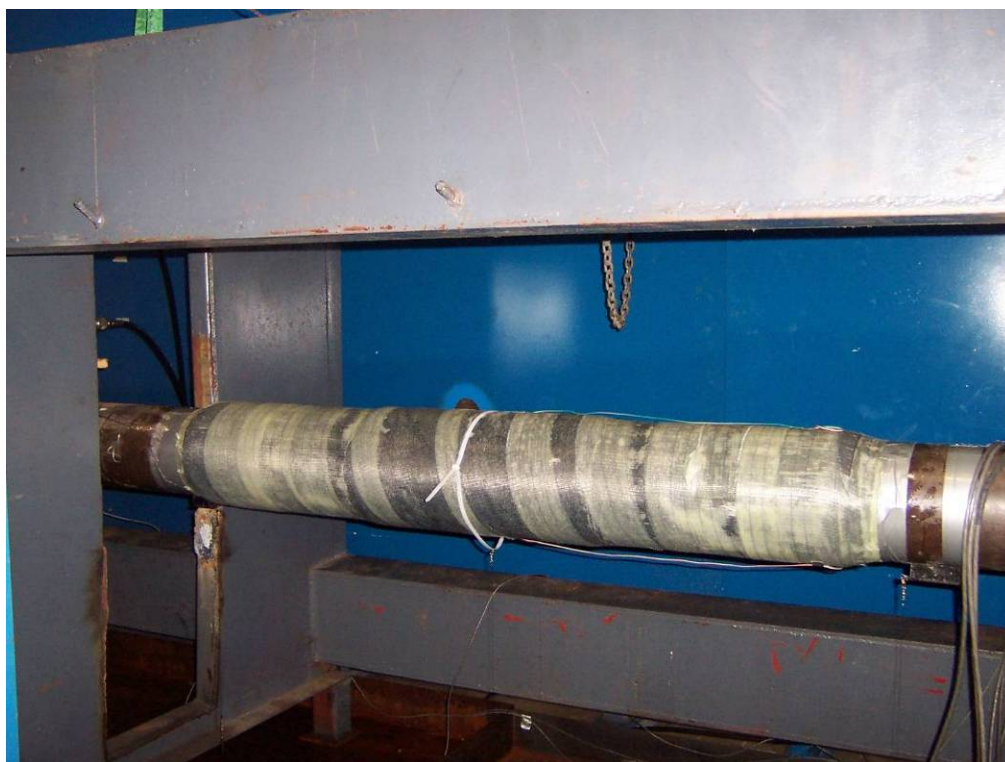
Figure 12 – Photo showing Product C prior to bend testing

Figure 12 is a photograph of the Product C repair in the load frame prior to bend testing.
