## ASSESSING THE USE OF COMPOSITE MATERIALS IN REPAIRING MECHANICAL DAMAGE IN TRANSMISSION PIPELINES

**Chris Alexander**  
Stress Engineering Services, Inc.  
Houston, Texas  
[chris.alexander@stress.com](mailto:chris.alexander@stress.com)

**Franz Worth, P.E.**  
Air Logistics, Inc.  
Azusa, California  
[fworth@airlog.com](mailto:fworth@airlog.com)

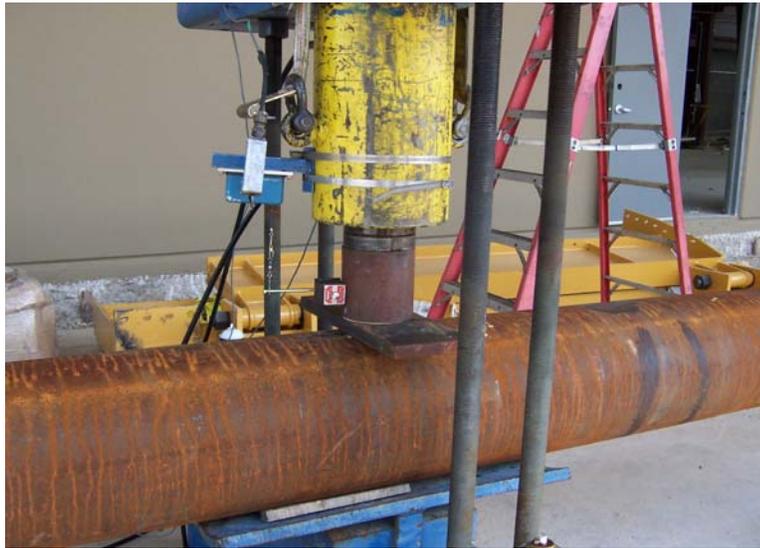
Figure 1 - Dent installation rig to install dents

3. Install dents in the pipe using a 6-inch wide plate. The initial indentation depth was 15 percent of the pipes outer diameter and the indenter plate. Four dents were installed in each 20-ft long pipe samples. Each dent was offset 2 inches longitudinally from the respective gouge, resulting in a total defect length of 8 inches. Figure 1 shows the dent installation rig.

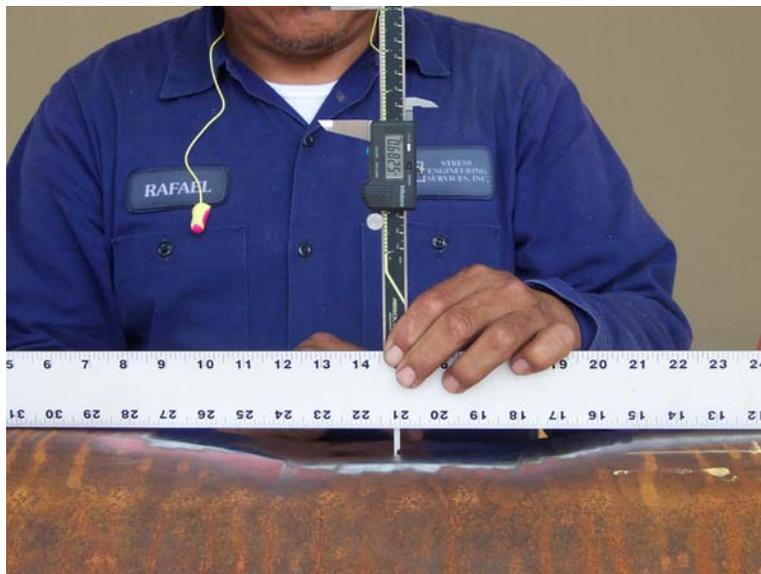
Figure 2 - Measuring dent depth and profile

4. Allow each dent to reround elastically with removal of the indenter and measure the longitudinal profile (side view of dent and process shown in Figure 2).

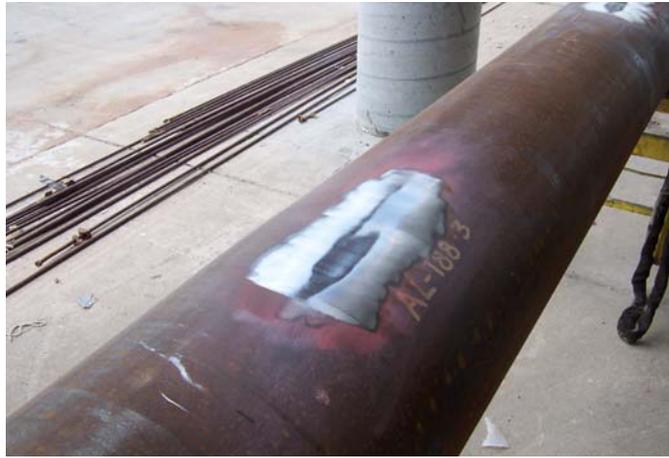
**Figure 3 – Gouge removal by grinding**

1. Remove the gouge by grinding with a hand-held grinder. Dye penetrant was used to ensure that the crack was completely removed. Measure the remaining wall thickness. Figure 3 shows one of the samples polished in its final state before installation of the repair material.

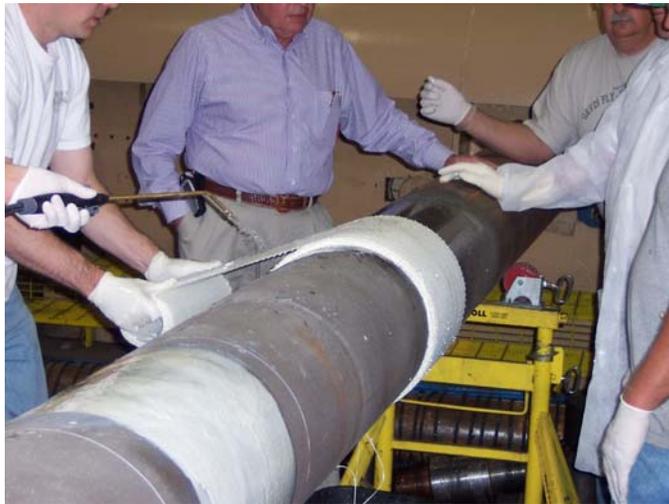
**Figure 4 – Installing composite material on pipe**

Figures 4 and 5 are photographs taken during the installation of the composite repair on the damaged sections of the test pipes.

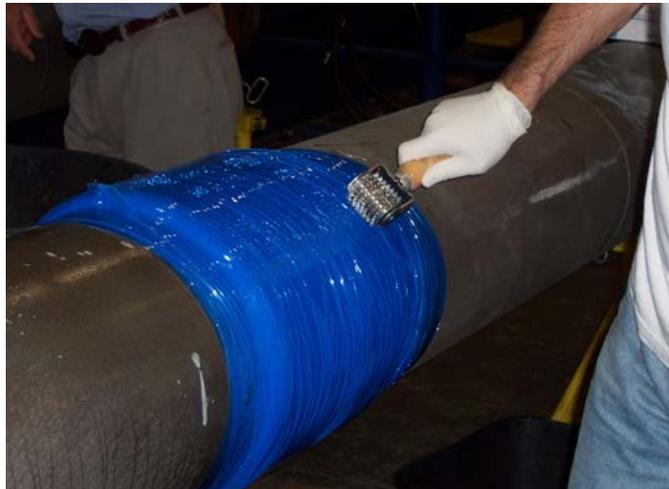
**Figure 5 - Perforating plastic wrap to permit off-gassing during cure**

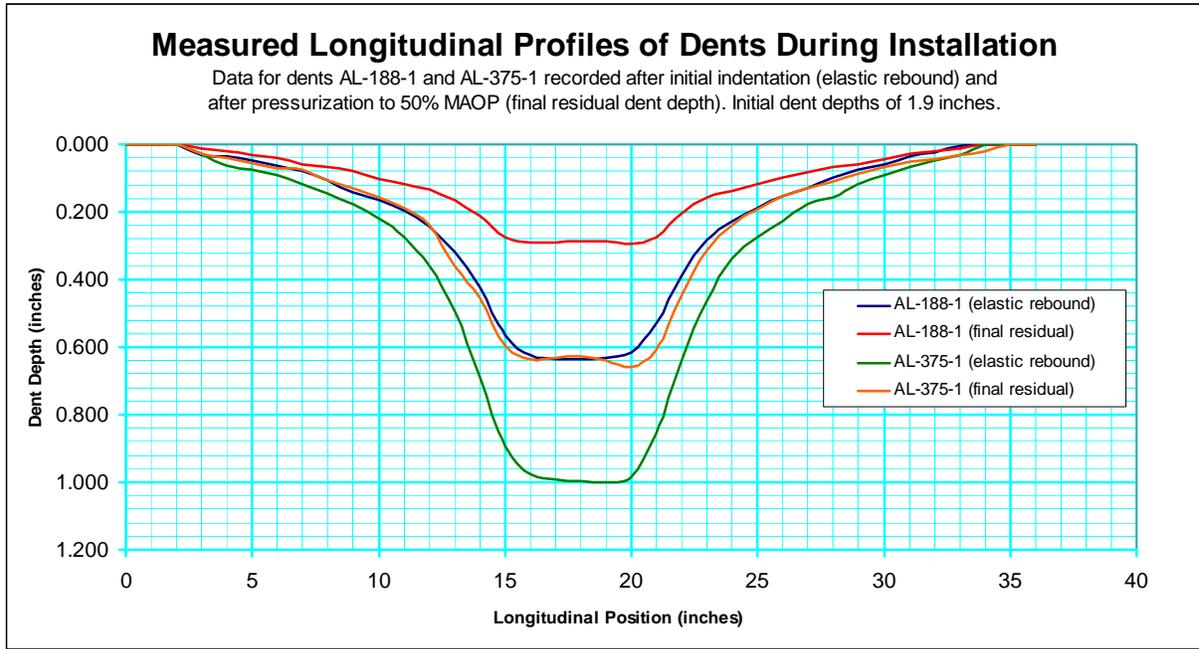
Figure 6 - Longitudinal profile measurements of exemplar dents

Figure 6 shows the longitudinal profile measurements for test samples AL-188-1 and AL-375-1. The measurements correspond to readings taken after initial indentation that capture the elastic rebound and measurements taken after pressurization to 50 percent MAOP. As with

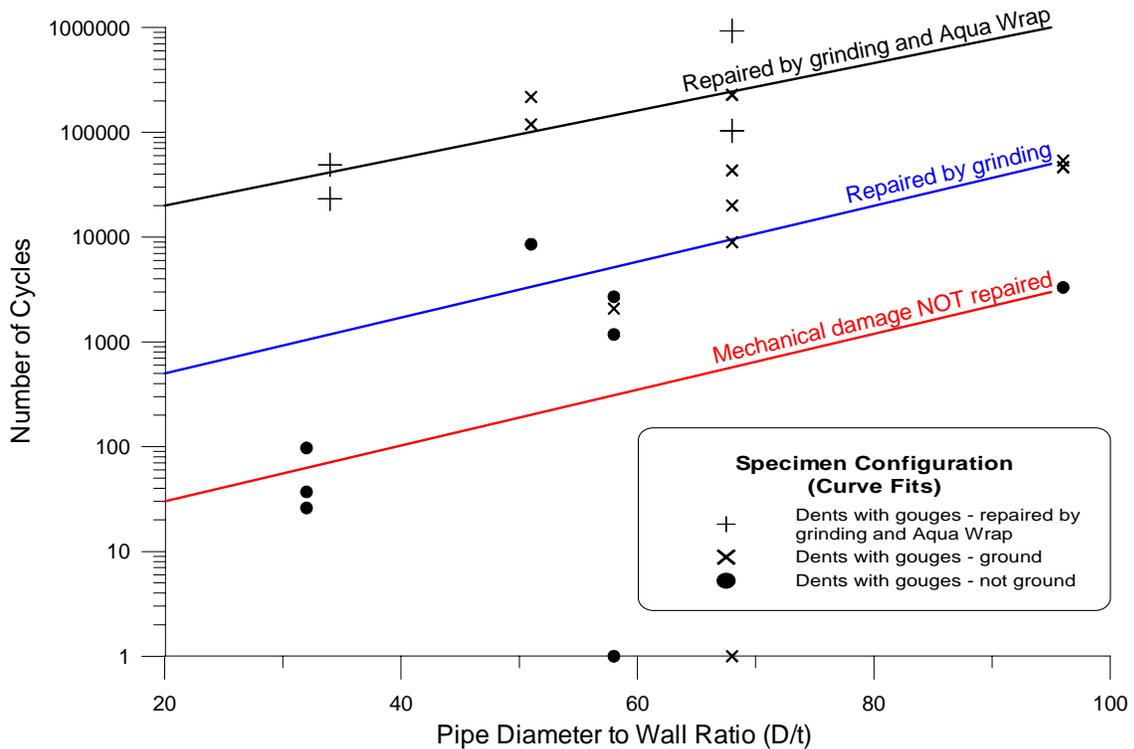
## NUMBER OF CYCLES AS A FUNCTION OF PIPE DIAMETER TO WALL THICKNESS RATIO

Data plotted are based on a cyclic pressure range of 50% MAOP  
All defects involved a dent of 15 percent (d/D) and a gouge depth of 15 percent (d/t)

Figure 7 - Fatigue test results for mechanically-damaged samples

In addition to the tabulated data, Figure 7 presents results that show cycles to failure for the composite-repaired samples, as well as data from previous research programs associated with mechanical damage. The predominant observation made in viewing this figure are the benefits derived in repair by grinding and using composite materials as compared to unrepaired mechanical damage. If one considers a pipe having a D/t ratio of 50 with a dent of 15 percent and a gouge of 15 percent, the fatigue life can be estimated from Figure 7 as follows.
